Skirting waterproofing restoration, natural stone masonry renovation plaster and horizontal barrier

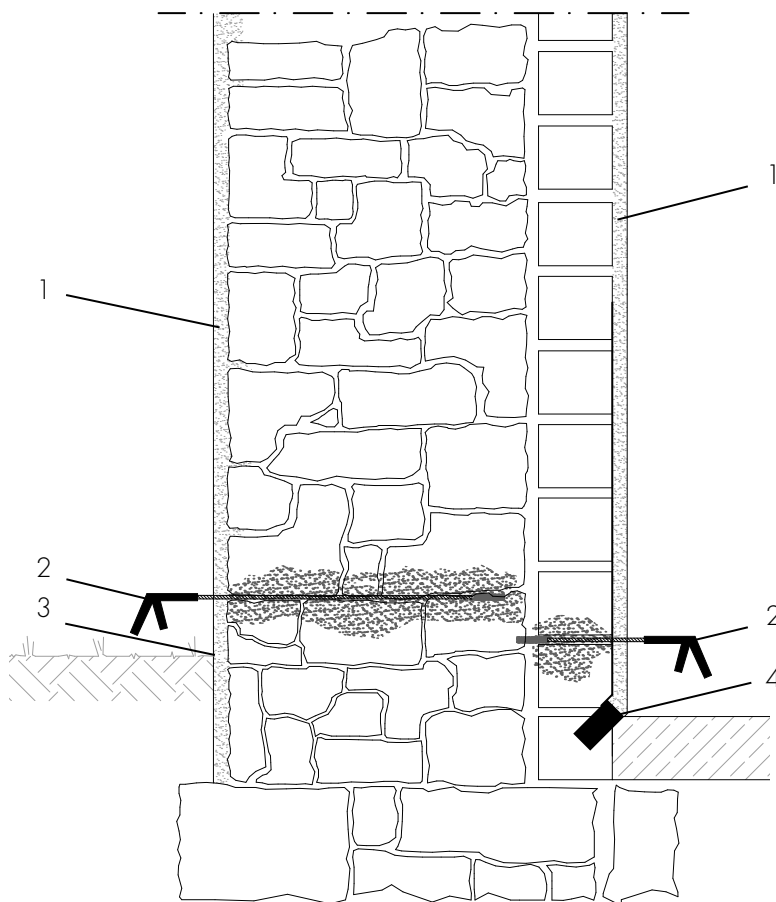
- 1 Restored render incl. sprayed plaster - THERMOPAL-ULTRA- Restoration render system for the absorption of salts harmful to buildings
- 2 Retrospective horizontal barrier - AQUAFIN-i380 - Installation of a retrospective horizontal barrier to prevent capillary rise of moisture in masonry
- 3 Building skirt render - ASOCRET-M30 - Protection of the waterproofing from damage and visual design of the building skirt area
- 4 Locking groove and sealing cove - ASOCRET-M30 - Locking groove and rounding of the internal corner
